# **TEST REPORT**

Report Ref. No.	15EMC-RT-1588		
Date of issue	2015-03-02		
Applicant			
○ Name	Samsung Techwin Co., Ltd.		
○ Address	84, Jeongdong-ro, Seongsan-gu, Changwon-si, Gyeongsangnam-do, Korea		
Factory			
∘ Name	1. TIANJIN SAMSUNG TECHWIN OPTO-ELECTRONIC CO., LTD 2. Samsung Techwin Co., Ltd.		
∘ Address	<ol> <li>No.11 Weiliu Road. Micro-Electronic Industrial Park Jingang Road Tianjin 300385, China</li> <li>84, Jeongdong-ro, Seongsan-gu, Changwon-si, Gyeongsangnam-do, Korea</li> </ol>		
Equipment			
○ Product	Network Camera		
	SNO-L6083RN, SNO-L6083RP, SNO-L5083RN, SNO-L5083RP,		
∘ Model	QNO-7010R, QNO-7020R, QNO-7030R, QNO-6010R, QNO-6020R,		
	QNO-6030R, QNO-6070R, QNO-7080R		
Standard	IEC 62262 and IEC 60068-2-75		
Technician	Hyunwook, Song		
Approved	Jaekyu, Lee 7. k. k

Degree of protection provided by enclosure for external impacts IK10

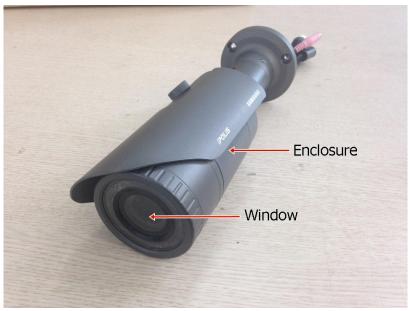
#### 5. Drop Zones:

The areas that were focused upon for this impact test are as follows:

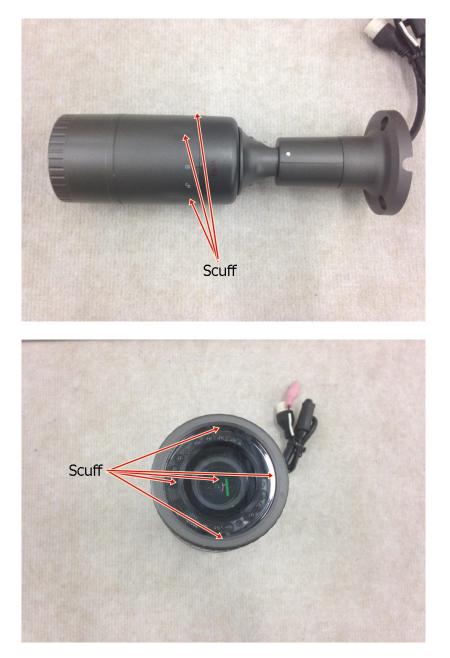
#### 7. Images

Drop Zone: Window		
Drop #	Orientation / Results	Pass / Fail
Drop 1	Vertical drop onto center of Window, Scuff	Pass
Drop 2	Normal to surface of side Window. Scuff	Pass
Drop 3	Normal to surface of side Window, about 90° circumferentially from previous drop. Scuff	Pass
Drop 4	Normal to surface of side Window, about 90° circumferentially from previous drop. Scuff	Pass
Drop 5	Normal to surface of side Window, about 90° circumferentially from previous drop. Scuff	Pass

Drop Zone: Enclosure		
Drop #	Orientation / Results	Pass / Fail
Drop 1	Normal to surface of enclosure. Scuff	Pass
Drop 2	Normal to surface of enclosure, about 90° circumferentially from previous drop. Scuff	Pass
Drop 3	Normal to surface of enclosure, about 90° circumferentially from previous drop. Scuff	Pass
Drop 4	Normal to surface of enclosure, about 90° circumferentially from previous drop. Crack	Pass
Drop 5	Normal to surface of enclosure, about 90° circumferentially from previous drop. Crack	Pass

After testing according to the procedure set forth by IEC 62262, model SNO-L6083RN, SNO-L6083RP, SNO-L5083RN, SNO-L5083RP, QNO-7010R, QNO-7020R, QNO-7030R, QNO-6010R, QNO-6020R, QNO-6030R, QNO-6070R, QNO-7080R was found to meet the criteria required for an IK10 specification.
